Contract #: 04-0120F4Cty: SF/ALA Rte: 80 PM: 13.2/13.9File #: 69.28**WELDING INSPECTION REPORT****Resident Engineer:**Siegenthaler, Peter**Address:** 333 Burma Road**City:** Oakland, CA 94607**Report No:** WIR-025309**Date Inspected:** 05-Jul-2011**Project Name:** SAS Superstructure**OSM Arrival Time:** 700**Prime Contractor:** American Bridge/Fluor Enterprises, a JV**OSM Departure Time:** 1900**Contractor:** Zhenhua Port Machinery Corporation, Ltd (ZPMC), Changxing Island **Location:** Shanghai, China**CWI Name:** Mr. Mai Quin Li**CWI Present:** Yes No**Inspected CWI report:** Yes No N/A**Rod Oven in Use:** Yes No N/A**Electrode to specification:** Yes No N/A**Weld Procedures Followed:** Yes No N/A**Qualified Welders:** Yes No N/A**Verified Joint Fit-up:** Yes No N/A**Approved Drawings:** Yes No N/A**Approved WPS:** Yes No N/A**Delayed / Cancelled:** Yes No N/A**Bridge No:** 34-0006**Component:** Bike Path Components**Summary of Items Observed:**

WELDING INSPECTION REPORT

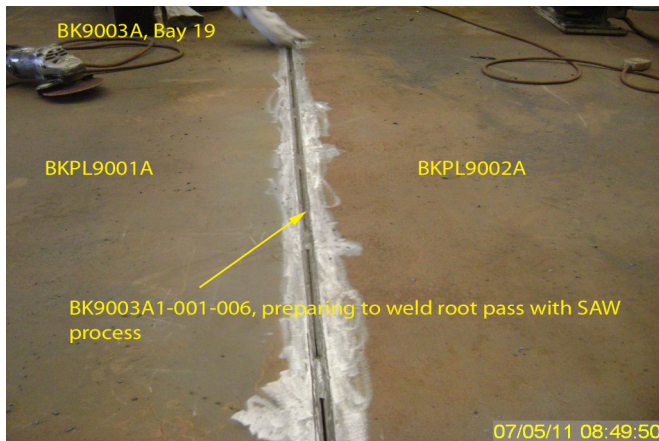
Unless otherwise noted, all work observed on this date appeared to be in general compliance with the applicable contract documents.
